**Flood Control Project Maintenance
Levee Inspections**

Maintenance Issue Types Only, Levee Inspection Report By Mile - Fall 2018

City of Sacramento

Waterway	Bank	Unit Miles	Inspection Start/End	Inspector
Unit No. 01 Sacramento River	Left	3.67	09/21/2018 09/21/2018	Luz Dial

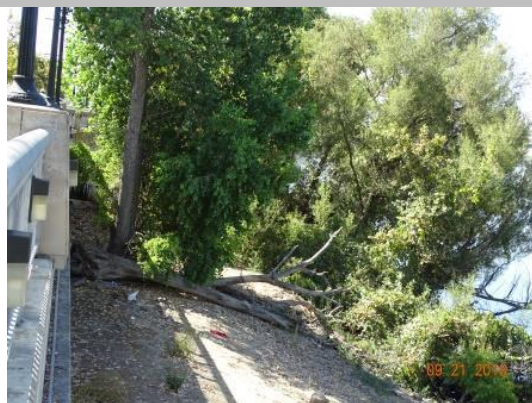
Photo 1 of 1 : FA_2018_NA0005_251_83_20180927_00113.jpg

LM Start	0.84	Rating **	M	Issue No.	83
LM End	0.84	Issue Type +	Ma	Location *	WS
Category	Earthen Levee			GPS Latitude/Longitude	
				Start	End
Item	Encroachments			38.578955 °	38.578955 °
				-121.507703 °	-121.507703 °
DWR ID	DWR_NA0005_01_f_2018_83				
Comment Code					
TR : Tree or limb					
Inspector Comment					
Log next to floodwall should be removed.

Tree debris against floodwall. Fall 2018

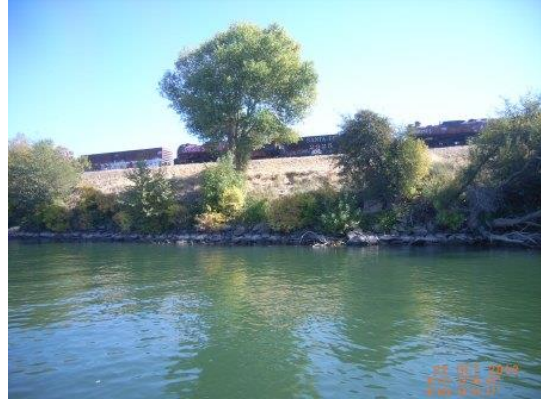
USACE 2013 Photo #1

LM Start	1.31	Rating **	M	Issue No.	72
LM End	1.39	Issue Type +	Ma	Location *	WS
Category	Supplemental			GPS Latitude/Longitude	
				Start	End
Item	2017 USACE Erosion Survey, DRAFT			38.573169°	38.572277°
				-121.511998°	-121.513063°
DWR ID	DWR_NA0005_01_f_2018_72				
Comment Code					
Inspector Comment					
2017 Site ID: SAC 58.5 L					
Status: Eroding					
2017 Field Notes: Slump sections along mid bank. City requested PL 84-99 assistance.					
Site History: 2008 - Oversized levee, should be repaired under maintenance. 2009 - Shallow slumps at the mid bank. 2010 - Some minor erosion at the toe, likely from wave wash. Some new shallow slumps. 2011 - One new tree has fallen. 2013 - Erosion continues on the slope surface, site extended upstream.

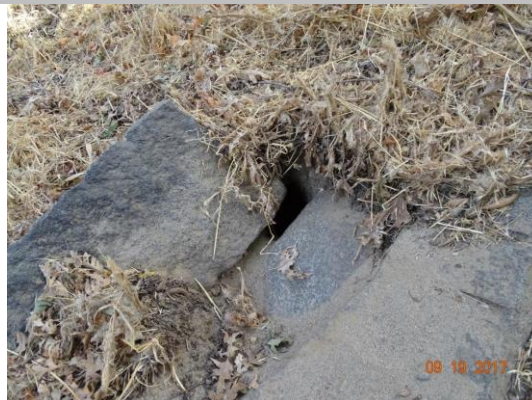
Photo 1 of 1 : FA_2018_NA0005_251_82_20180917_00012.jpg

LM Start	2.31	Rating **	A/W	Issue No.	82
LM End	2.31	Issue Type +	Ma	Location *	WS
Category	Earthen Levee			GPS Latitude/Longitude	
				Start	End
Item	Animal Control			38.559767°	38.559767°
				-121.515264°	-121.515264°
DWR ID	DWR_NA0005_01_s_2016_82				
Comment Code					
A3 : No rodents visible, but rodent burrows visible; need to backfill and compact or grout burrows.					
Inspector Comment					
City of Sac grouted this area and will continue to monitor.

View of rodent hole on waterside slope. Fall 2017.
